# Mirador “El Palmeral” Casa Consistorial Vitoria-Gasteiz

Project report

# Tradition meets innovation – Window restoration at the Mirador “El Palmeral”

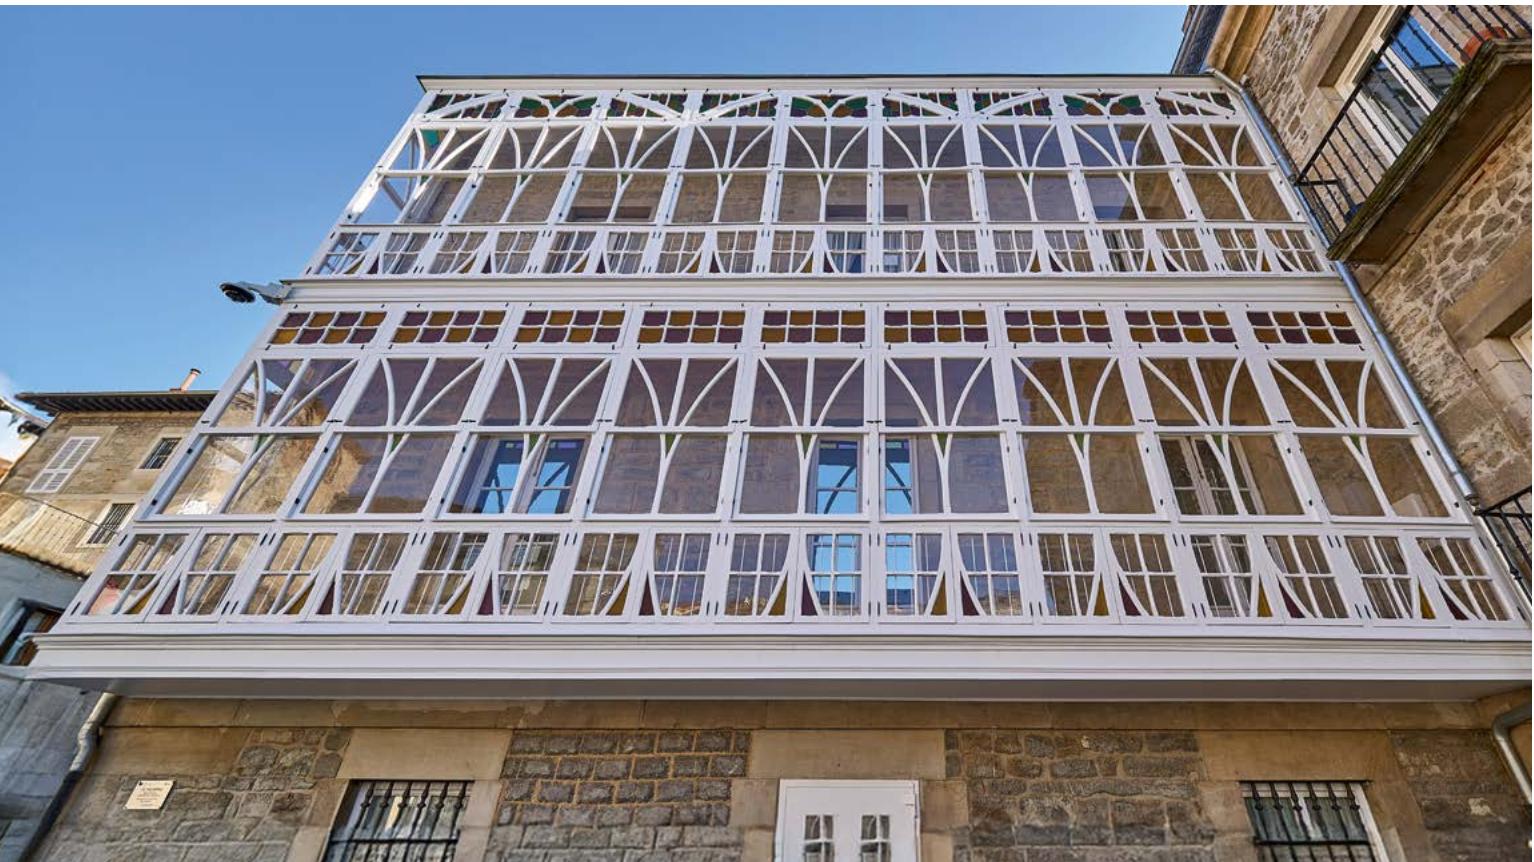
Preserving some of the historic windows while reconstructing others to match the originals was particularly demanding. The original elements were made of blown glass, whose typical irregularities required preserving.

An added complexity was the different window shapes, sizes and patterns, which required precision design planning and documentation. Each glass element needed dismantling, numbering, and analysis to identify damage and ensure accurate restoration.

Wherever possible, damaged original panes were repaired or restored using techniques such as the Tiffany method. Where replacement was necessary, custom-fit replicas made from SCHOTT RESTOVER® plus were used. Each element could be precisely manufactured and installed true to the original thanks to detailed plans drawn up in accordance with the CVMA standard (Corpus Vitrearum Medii Aevi) and close cooperation between the team of architects, SCHOTT, and glass restorer Mikel Delika. The outcome can be seen as a successful combination of historical preservation, precision craftsmanship, and modern glass technology.
